## BLISTERS OR BUBBLES

Source: American Sports Builders Association

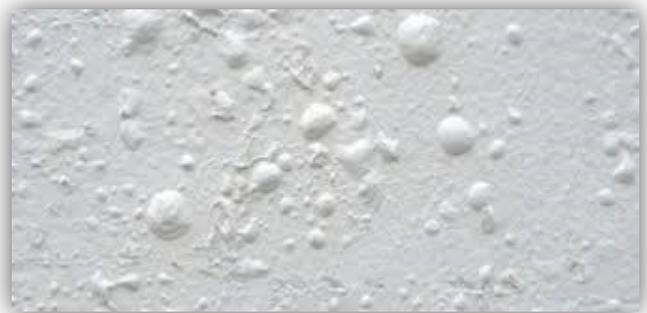
Blisters or bubbles in the colour coating on asphalt and concrete courts most often are caused by moisture between the pavement and the coating material, within or beneath the pavement. Since both asphalt and concrete can absorb moisture, moisture trapped below the slab can be drawn up through the pavement or moisture may come from the pavement itself if the slab is incompletely dried or is experiencing severe drainage issues prior to the application of coating materials.

Whenever water is present on, in or beneath a tennis court pavement, heat from a warm day can draw the moisture upward to the surface where, if trapped, it vaporizes and expands. Most modern tennis court coatings are semipermeable and allow a small amount of moisture to escape. However, if larger amounts of moisture are present, if too many coats of surfacing have been applied, if the coats are too thick or if impermeable coating materials have been used, the water cannot escape and the trapped vapour breaks the bond between the coating and slab, forming a bubble. Bubbles also may form between layers of coating.

Bubbles may also be caused by contamination of base materials during construction. Salts, organic residues, curing agents, clay balls, dust balls and oil spills are all materials that can cause bubbling or blistering in a tennis court surface. Blisters may also occur if a surface is not properly cleaned prior to application of colour coatings and, therefore, the new coatings do not properly adhere to the surface.

Small bubbles may be punctured with an ice pick or nail and pressed down, which may make them re-adhere if there is still liquid or semi-dry binder under the bubble. If not, adhesive must be injected with a syringe to facilitate bonding. Large bubbles may be cut open and reattached to the pavement with an adhesive.
