## OBSERVATIONS ON NEWLY COATED TENNIS COURTS

Source: American Sports Builders Association

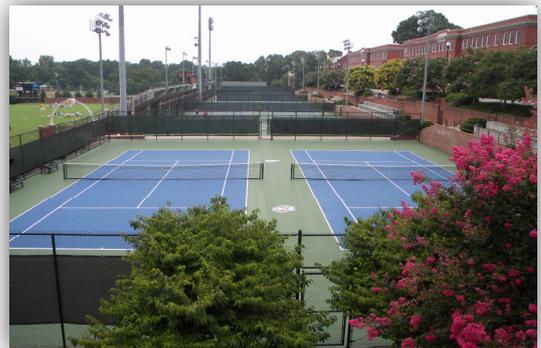
Owners, anxious to try out a new surface, may use the court before it is fully cured. When a player stops quickly or twists his shoe, the colour coating may become detached from the asphalt bound undercoats. This is particularly true if the player has tennis shoes with deeply grooved patterns on the soles. Play should not be allowed until proper curing of the surface has occurred.
